SERVICE BULLETIN #14

To: All Major Pump Customers

Subject: Hale CBP Booster Pump

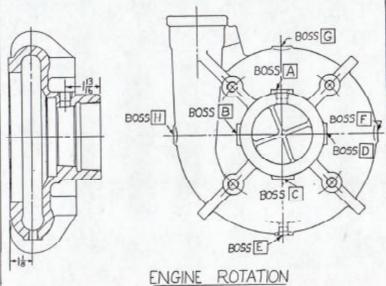
SK-145

The Hale Service Department has examined a number of CBP installations with improperly located priming connections.

We have found that nine out of ten service calls concerning slow priming or inability to prime are due to an improperly located priming connection.

The enclosed Plate #SK145 shows the proper priming location for the various CBP Pump discharge positions.

If, after the pump has been drilled, you find it necessary to change the discharge position, you should relocate both your priming and your drain taps. The attached sketch, SK145, gives the locations for both of these taps.
