SUPPLEMENTAL INFORMATION IDENTIFICATION OF RELIEF VALVES AFFECTED HALE SB149 - NHTSA RECALL 17-E056

Hale released a recall under SB149 (NHTSA 17-E056) in late 2017 to vehicle manufacturers. There are some relief valves that may have snap rings that were supplied to Hale that were not stainless steel as specified. While there were only a couple cases where corrosion led to reduced life, Hale is providing repair kits and labor to ensure reliability. See official recall document SB149 for details.

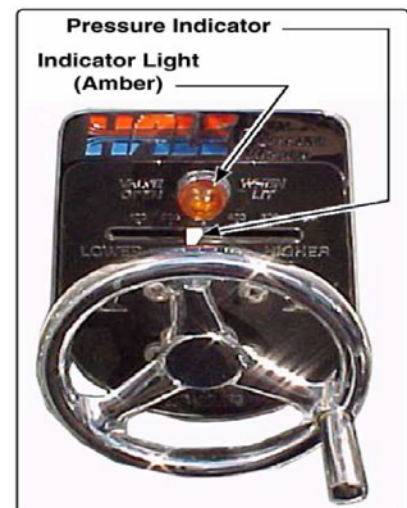
Vehicles affected by the SB149 recall will have a PM control hand wheel and placard on the pump panel as shown in the picture on the right. This includes TPM relief valve systems that include the pressure indicator shown. Also included in the recall are QG, and P Series relief valves which have a similar hand wheel and placard without the pressure indicator. This includes the P30, P35 and P40 relief valve systems.

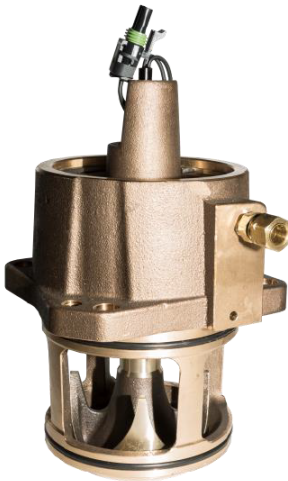
QG RELIEF VALVE

If the vehicle is equipped with a TPM it will have both a QG relief valve installed in the pump body and a PG30 installed to dump water to the ground. Therefore one of each kit will be required.

546-00066-000	Repair kit for QG/P35/P40 Relief Valve Retaining Ring
546-00066-001	Repair kit for P25/P30 Relief Valve Retaining Ring
